5-Year Record of Decision Review

BNSF Midland Market Rail Yard
Klamath Falls, Oregon

for
Oregon Department of Environmental Quality

January 31, 2012

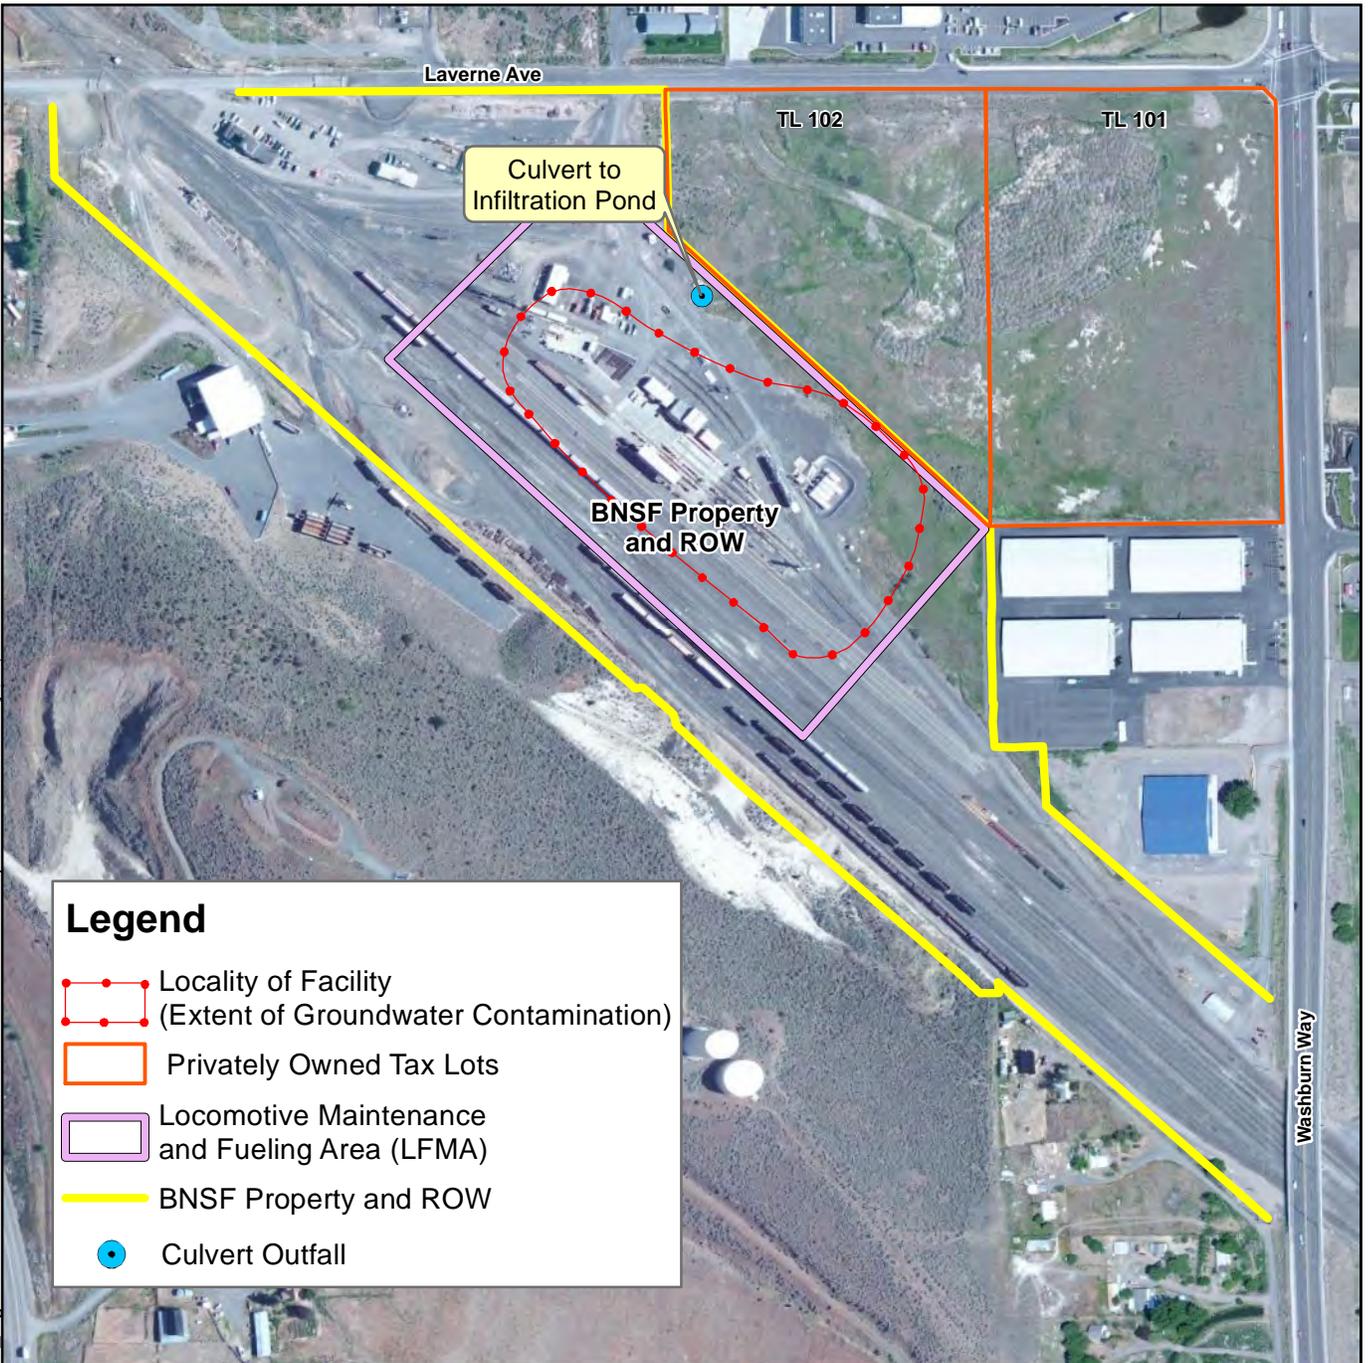
Site Plan	
BNSF Midland Market Rail Yard	
	Figure 1

The site continues to be used for maintenance and repair of rail cars and for fueling locomotives. The dissolved diesel plume in groundwater extends approximately 1,000 feet north to south and 400 feet in width. This area is considered as the LOF as documented in DEQ's ROD amendment (Figure 1) (DEQ 2008).
