Rowena Oil Spill

State of Oregon
Department of
Environmental
Quality

Land Quality Division Cleanup Program Eastern Region

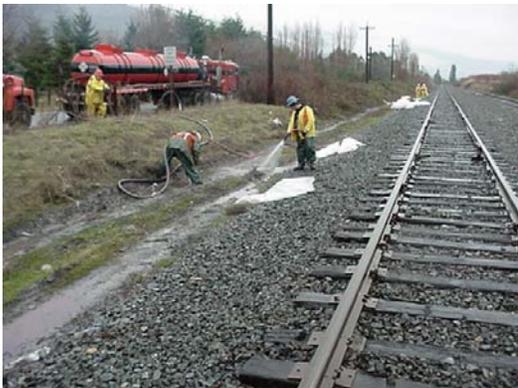
Emergency response personnel flush diesel fuel from ballast rock for collection in to vacuum trucks
