Subject: Historic Survey of Senz Automotive Service
210 South Maple Street
Yamhill, Oregon
File No. 2787-039-01

Senz Automobile Service IRAM/Site Investigation
Yamhill, Oregon

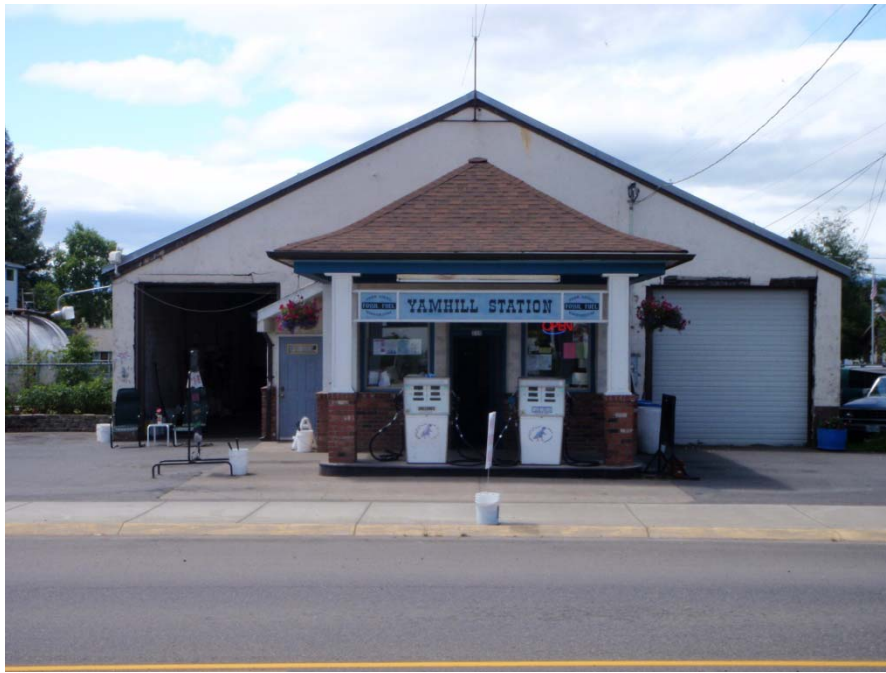
The Senz Automotive Service property is commercially developed and includes an active service station with an AST on the south side of the building, and an unpaved back lot (see photograph 1). The site comprises approximately 0.42 acres and includes a 2,784-square-foot building, a 5,227-square-foot paved parking lot and a 10,454-square-foot unpaved back lot.

Photo 1: Building overview, looking west

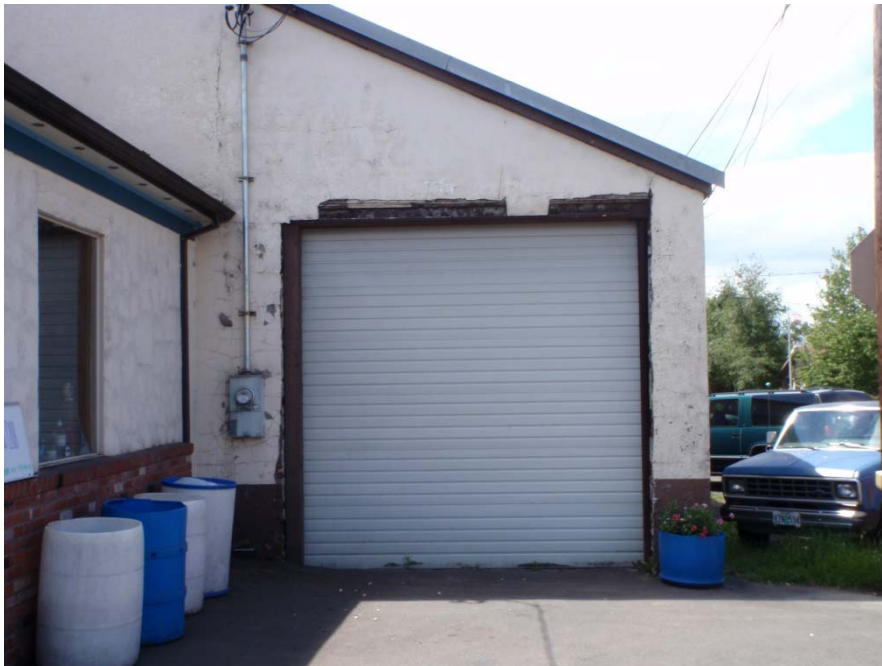
Photo 2: Roll up doors on the east side of the building

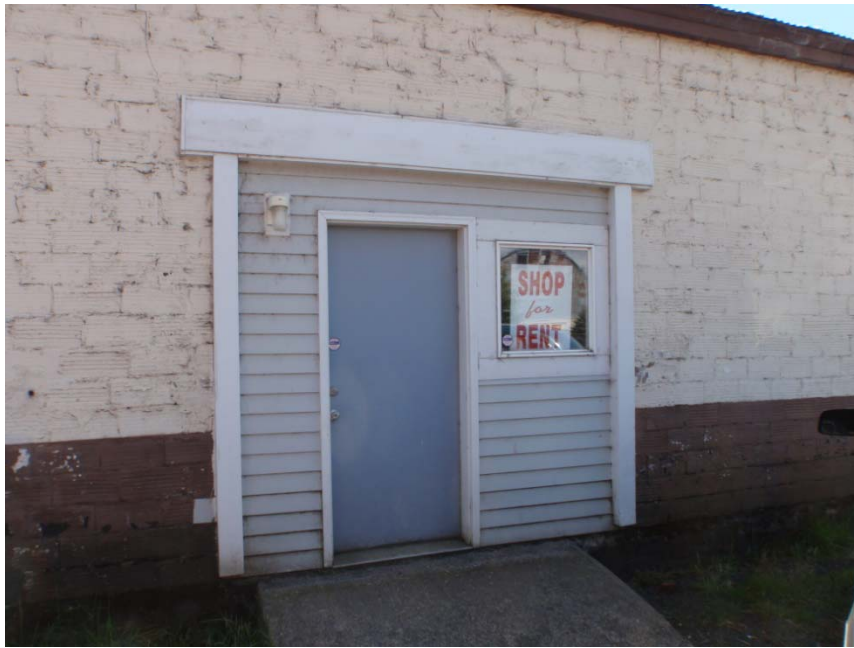
Photo 3: 2004 installed "man-door" on north side of the building

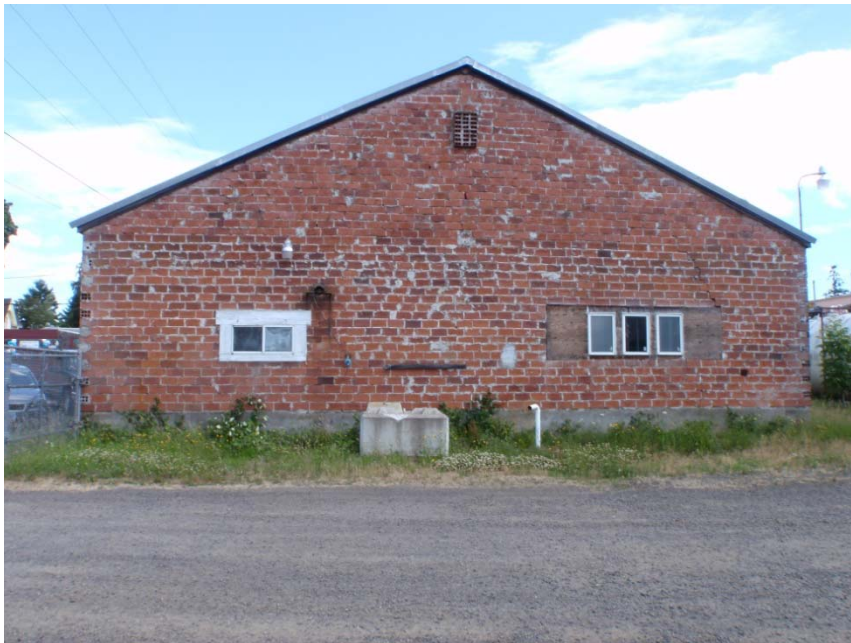
Photo 4: Rear window replacements, west side of the building

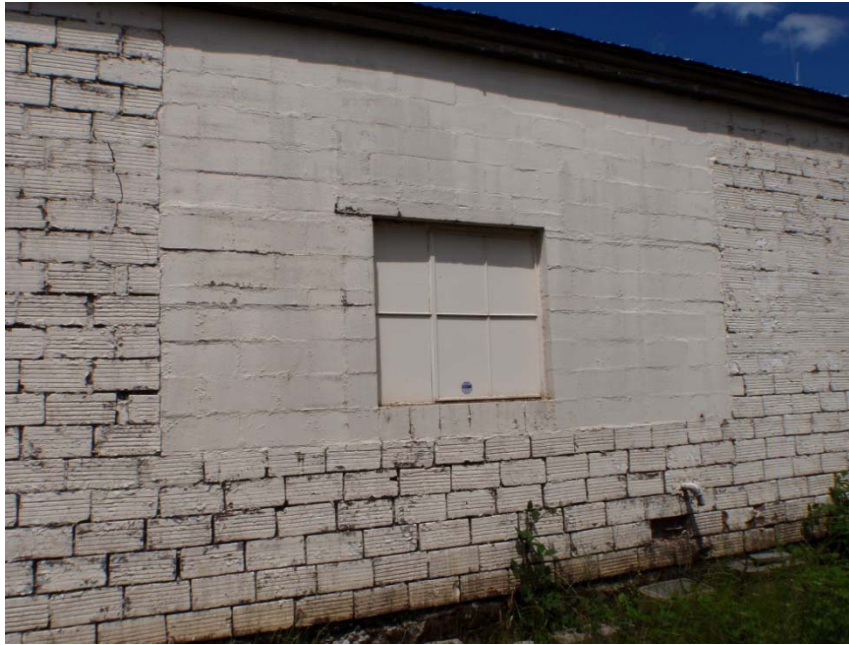
Photo 5: South side of building showing side window replacement

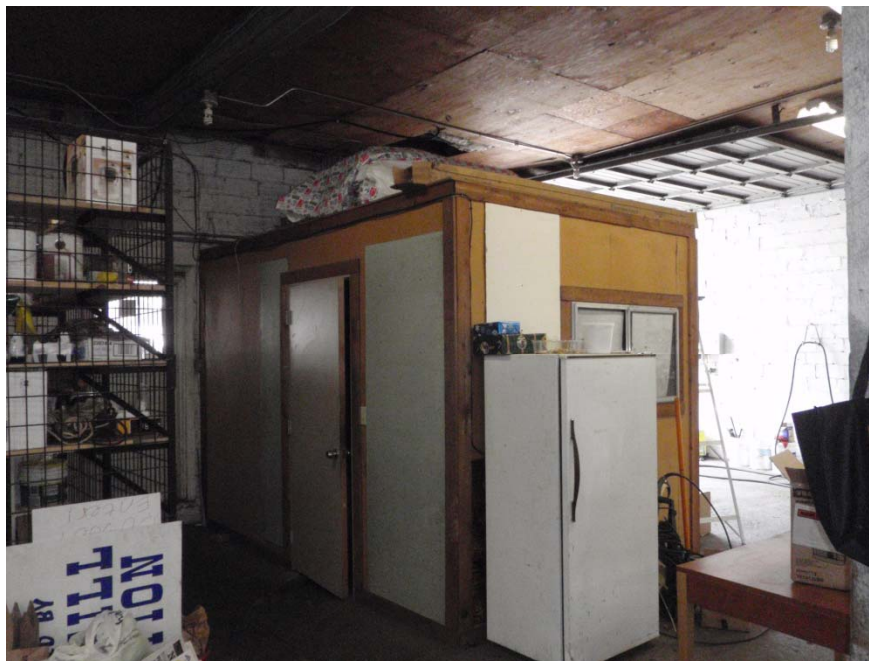
Photo 6: Showing interior modification
