Re: Soil Management Plan Project – Treated Storage Yard Bunk Installation
Amendment to include Repair of Damaged French Drain Discovered

This letter serves as an amendment to the original Soil Management Plan Project – Treated Storage Yard Bunk Installation, approved 11/6/2014.

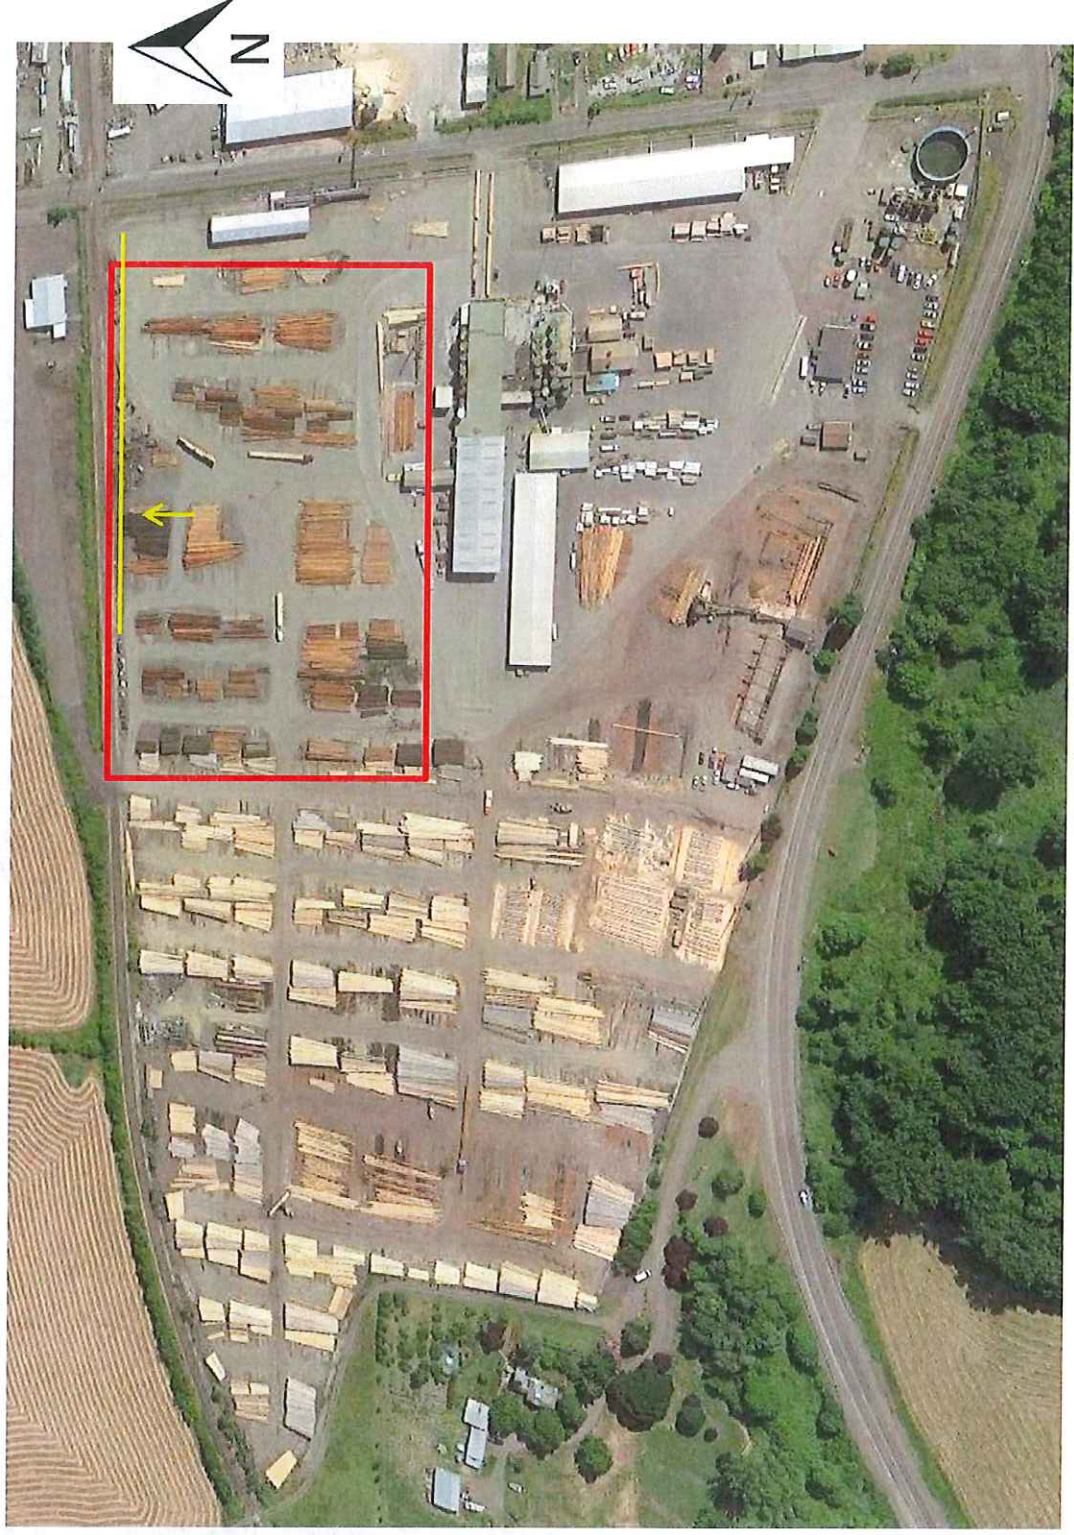
Figure 1. Bunk Installation Location, Damaged French Drain Location

In order to maintain the integrity of the French Drain traversing east/west along the northern boundary of the property line (See Figure 1) MCHI dug pot holes in order to locate the pipe. Three holes were dug to locate the pipe in order to provide a line of site. The location of the pipe was marked on the ground surface. The holes were approximately 1.5-2 feet in depth and revealed only clean fill material from the original installation of the French Drain. In one location (See Figure 2) a small portion of the French Drain was found to be damaged.
